## CASE STUDY

# A pre-2000 PET Bottling Line Main Gearbox/ Pinion Bearing

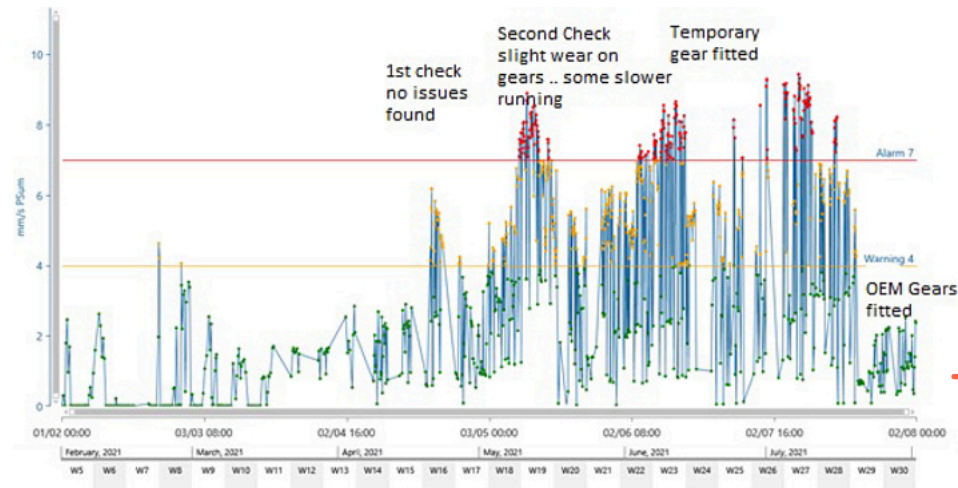
Figure 1  
- GBX O/P ISO  
velocity trend

Initially, the velocity levels on the main gearbox output increased from typically 2mm/s to exceed 5mm/s in early April 2021 (as seen in Figure 1). The site engineers were informed and asked to check for any looseness or signs of low lube as is normal in this type of increase. Engineering feedback stated there was no looseness and the gearbox oil levels were correct; an oil sample analysis showed no obvious wear particles.

The levels increased again fast through July (using the temporary printed gears) - as you can see from Figure 1; after the OEM gears were fitted in early August 2021, the levels dropped to pre-fault velocity levels of around 2mm/s RMS.

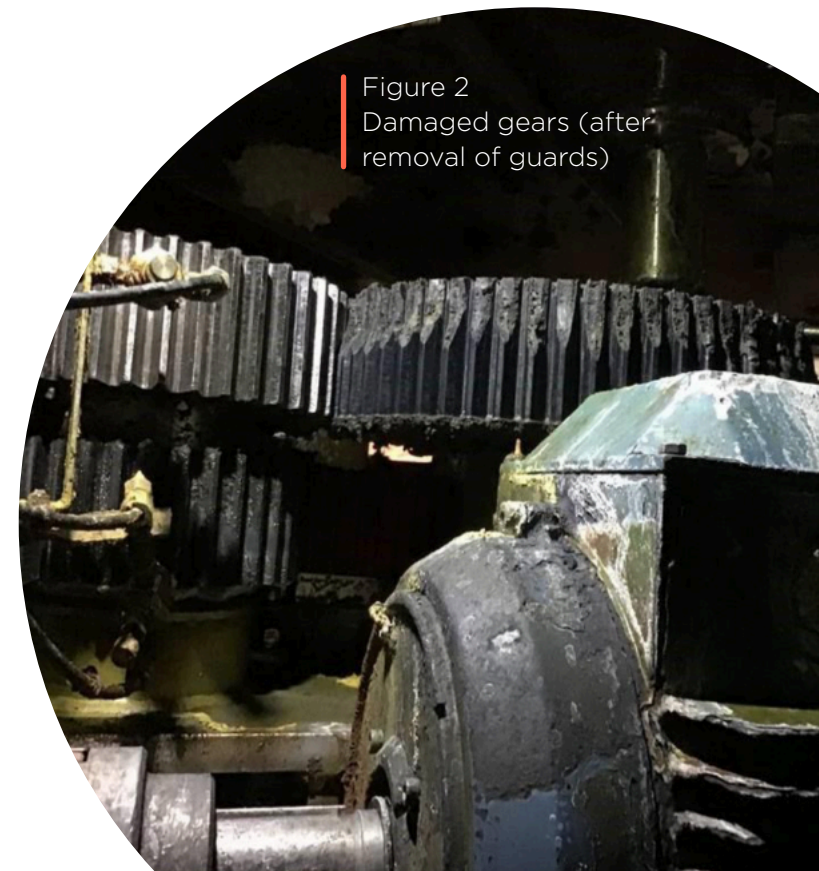
Figure 2  
Damaged gears (after  
removal of guards)

The levels increased again through May 2021 and a more detailed inspection showed gear wear - (see Figure 2, picture of damage). DIAGSOL engineers looked at the raw FFT and time domain data and multiple gear-mesh harmonics were dominant. The OEM gear set was 10-week delivery; hence the site engineers had a pair of gears printed as a temporary measure; these were fitted two weeks later.
